16TH MILITARY POLICE BRIGADE BARRACKS COMPLEX

**Volume II of II – Appendices E through L of Section 01010
and Sections 01012 through 13280**

ASBESTOS SURVEY

**BUILDING NO. 5517
FORT BRAGG, NORTH CAROLINA**

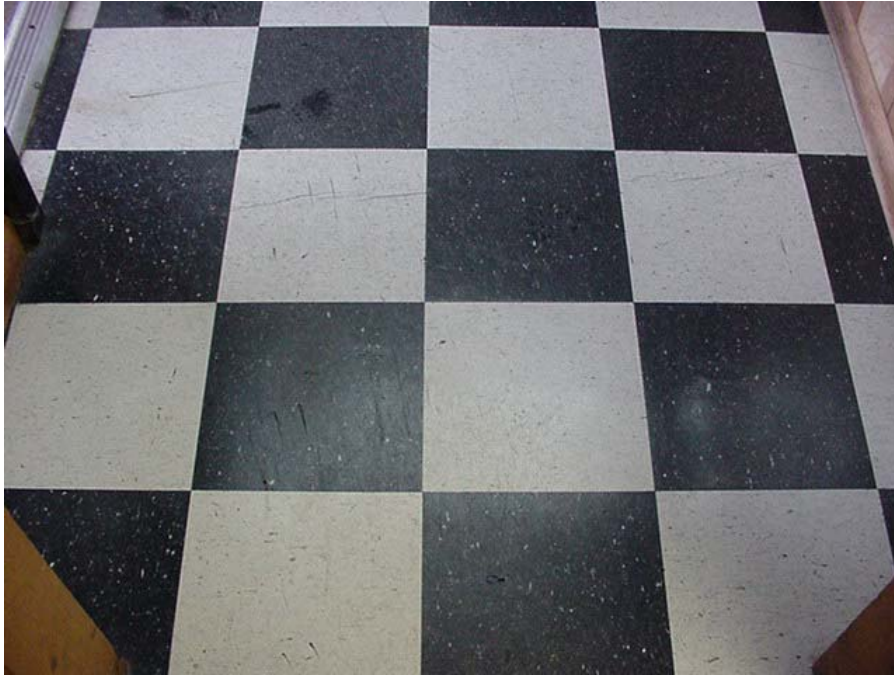
Figure 1. Both black with white highlights and white with black highlights 12" X 12" floor tiles contain positive amounts of asbestos.

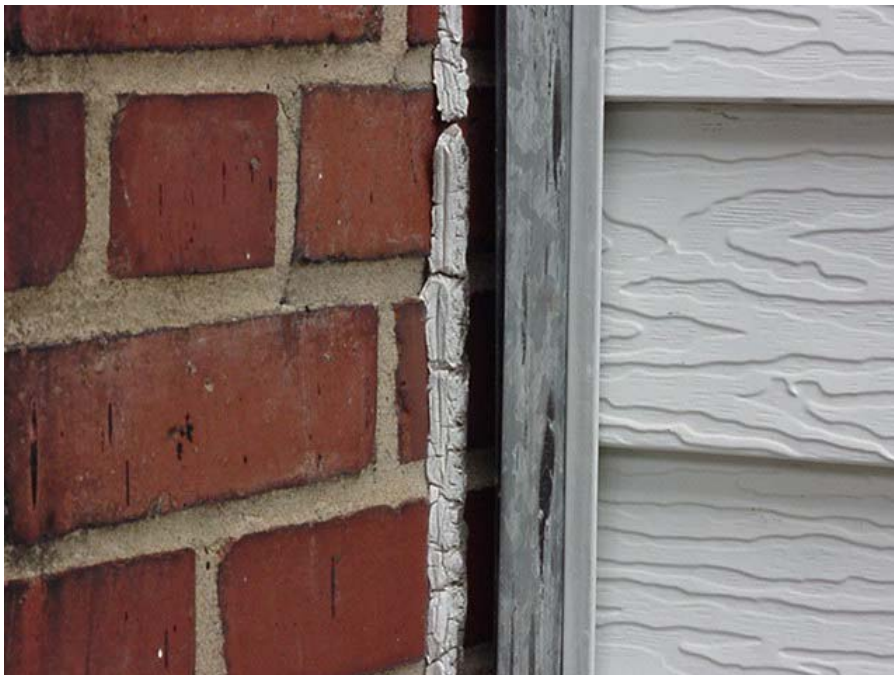
Caulking material between the brick chimney and siding was found to be asbestos containing.

Caulking material at the junction of siding and masonry brick chimney contains asbestos. This material may be found at other areas under newer aluminum siding.

Figure 2. Caulking material at brick chimney contains asbestos.

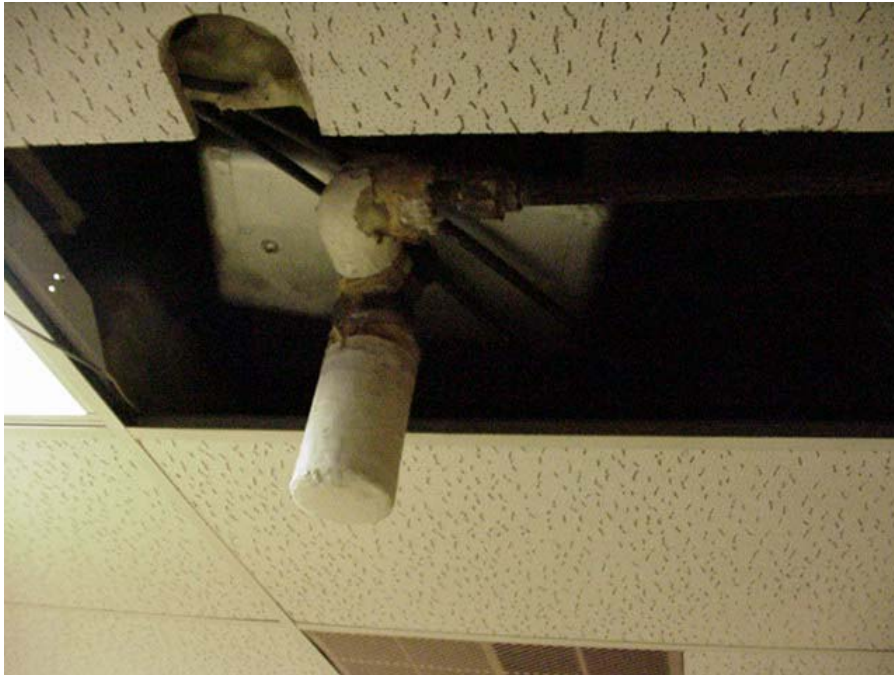
TSI pipe run insulation remnant at one steam unit heater contains asbestos.

Figure 3. TSI pipe insulation at unit heater in ceiling of office contains asbestos.

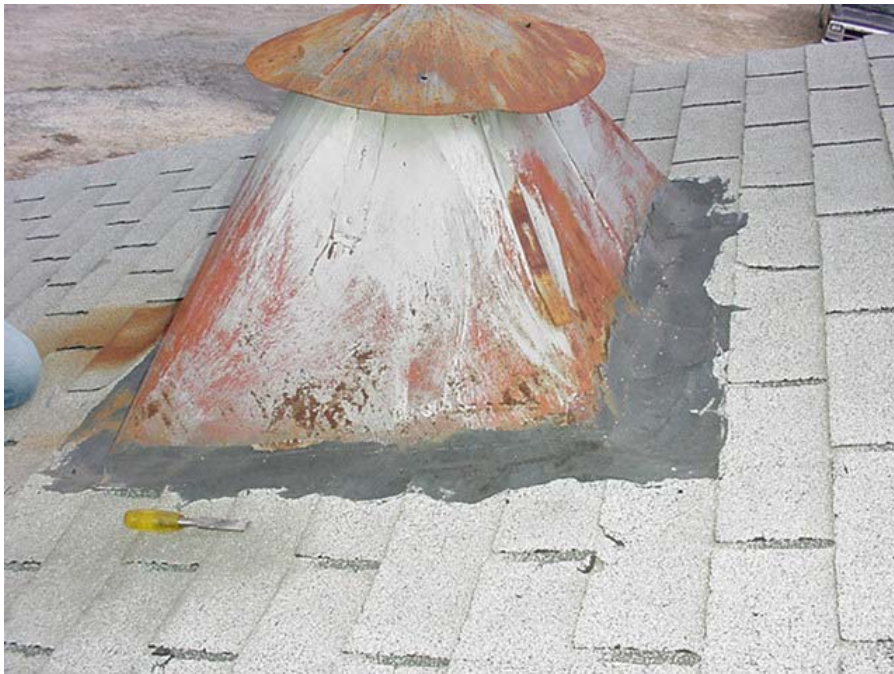
Troweled on roofing cement used as patching and flashing material was found to contain positive amounts of asbestos.

Figure 4. Roofing cement used as flashing and patching at metal roof vents and brick chimneys as well as junctions of roof sections contains asbestos.
